Refurbishment Report of a Roost / Funkshun Dual Drive Tube Amplifier

From Martin Schweizer

The amp is not operating after being in stock for several years in an old barn.

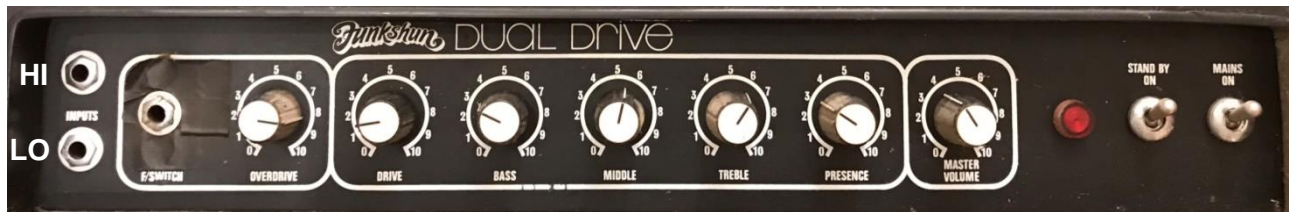
1.1. Block diagram of circuit

The model under investigation is a one channel amp with two inputs. A HIGH gain input normally for guitars and LOW gain input breaking down the amplitude of an input signal to half. The possibility of harmonic overdrive of the 2nd tube stage can be adjusted (DRIVE). An additional boost (OVERDRIVE) of the overdrive can be added. This additional boost can be switched ON and OFF with a foot switch. No Reverb which is available at other variants of the Funkshun Dual Drive.

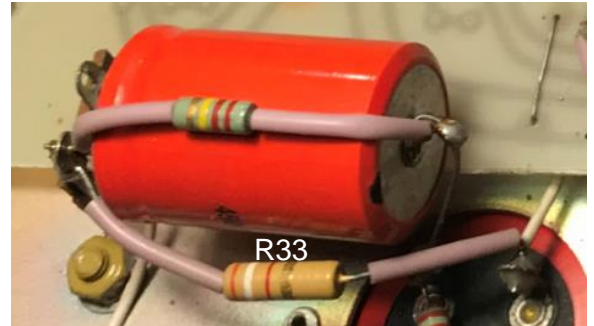
In the third stage the resistor R33 is differing from circuit drawings which could be found in WWW. Here instead of 1,5k Ω a 3,9k Ω value is equipped. As this looks like original equipped at the manufacturer, the reason for this difference must be the missing additional ECC83 triode powered from this stage in case of the Funkshun reverb variant. When the current of this driver triode for the reverb spring is missing R33 has to be enlarged to achieve the same voltage drop for the following filtering stage.

The resistor R17 for the next filtering stage was obviously already modified with an 82k Ω resistor (see picture right hand). As the reverb model powers two additional triodes, the 22k Ω from the schematic might be not adequate. The dimensioning of R17 will be discussed further below.

Under this condition the V2a will draw a quiescence current of 0,64mA and V2b of 1,0mA. As this is quite similar to the current of filtering stage variant 1, R17 will be set back to 82k Ω . To achieve only 10V further voltage drop with the defined quiescence current for V2a, the resistor R13 in the successor filtering stage of supply voltage has to be set to 15k Ω .

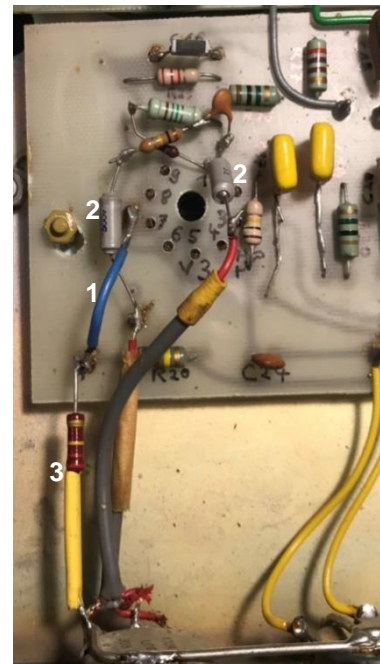
The Funkshun on the bench has a significant modification at the master volume. Comparing with original schematic the VR5 potentiometer has been shifted from the position between tone stack and the amplification stage V3b to a position after this amplification stage at the input of the cathode follower stage V3a.

The motivation for this change might be to provide higher signal levels to the output stage and have more distortion. Nevertheless, the modifications have been done in a rough and flying soldering style. Therefore, they will be removed and master volume will be integrated again in its original position.

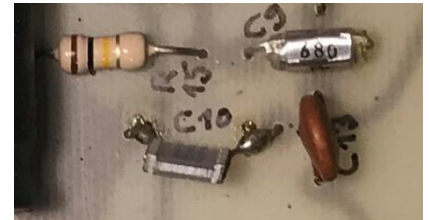
In the tone stack the bass coupling capacitors C10 was modified (see picture on the right side). A 6,8nF cap was mounted. It has been replaced with 22nF according to the schematic (chap. 3.7).

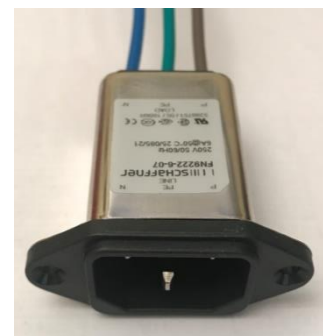
Therefore, a substitute with an X2 capacitor 68nF 275VAC (PME271M568MR30) and two ferrite rings could be designed to provide a certain protection of the amp against disturbance from the mains supply.

Add EMC protection with X2 capacitor 68nF 275VAC (PME271M568MR30) and two ferrite rings (see chap. 3.19).

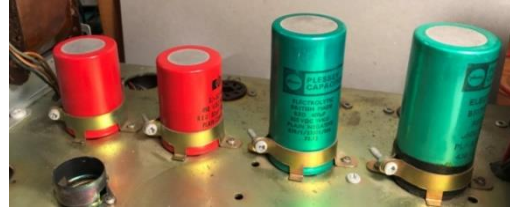
2.2. Electrolytic Capacitors

The larger capacitors in the Funkshun especially those to smooth the high voltage are electrolytic capacitors. This type of capacitor could lose its electrolyte over lifetime and therefore losing its function; especially under the hot environmental conditions in an amp.

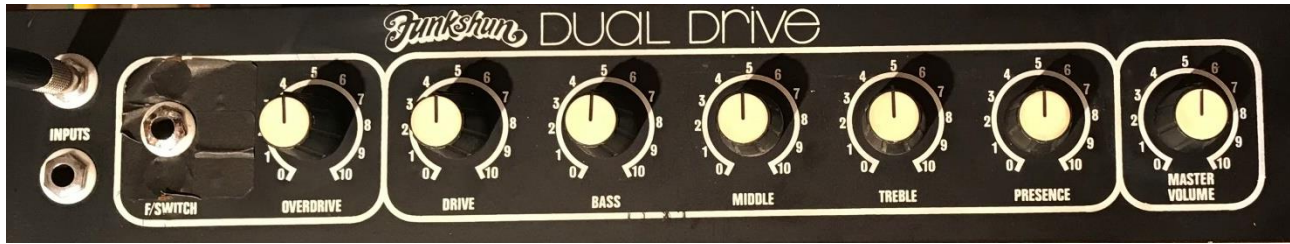
A.20.a) (94_000)

Complete signal path LOW gain input
Ch1= V2a ECC83 / Pin 2
Ch2= 80Ohm speaker simulator

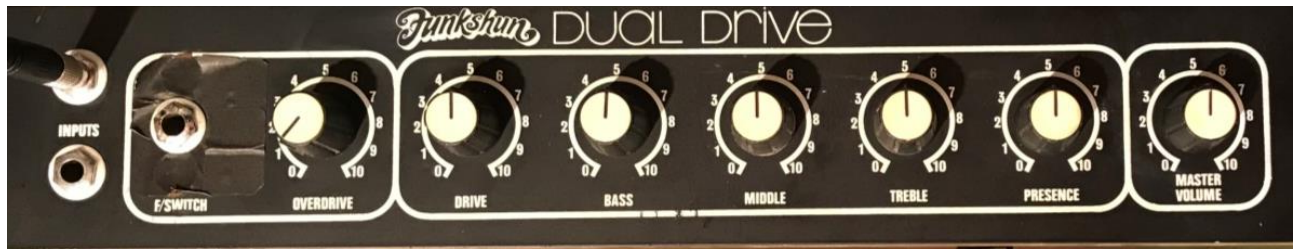
B.20) (97_000) Complete path

Ch1= V2a ECC83 / Pin 2

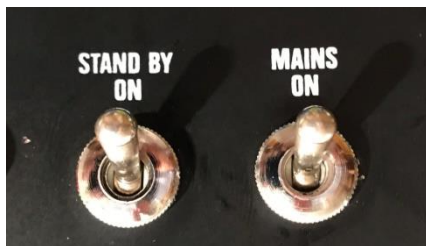
Toggle switches in the front panel

The standby switch was found to be unable to switch ON. As those old toggle switches are assembled with screws, they can be easily disassembled.

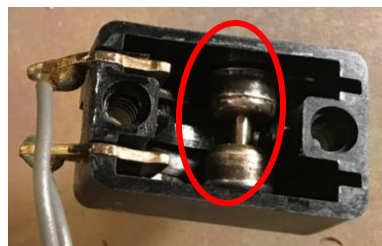
Open standby switch corroded

The internal view with dismantled toggle stick showed that the "toggle dumbbell" was totally corroded (red oval). With a fiberglass pen the silver-plated surfaces could be cleaned (green oval). Even the mains switch was still working it was also disassembled and cleaned. The picture shows the two toggle pieces of this bipolar switch. The right contact was already cleaned while the left piece is still with corroded surface.

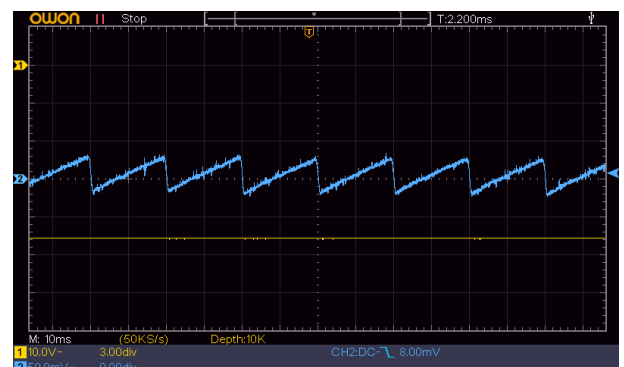
-46,4VDC

ΔV 45mV 50Hz ripple (~0,1%)

The ripple on the bias voltage could be reduced as expected by the calculation for ΔV .

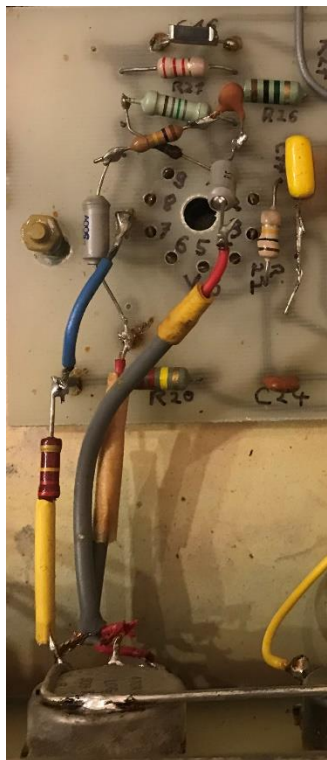
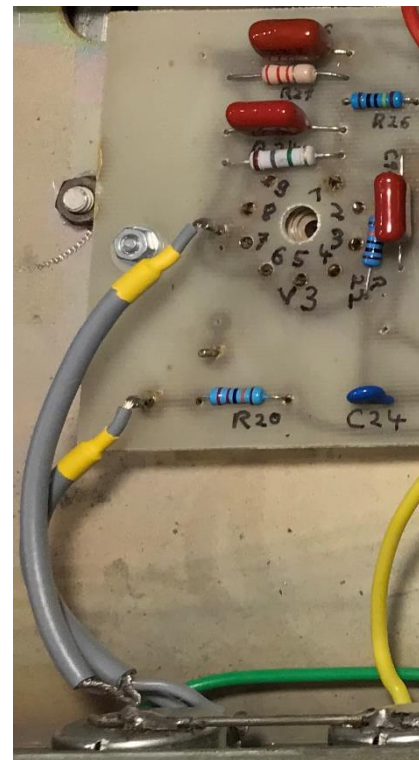
The PCB with the modification (left picture) shows a chaotic wiring made in a “flying” soldering style.

After removing the modification, the wiring is clean and much simpler without “flying” components.

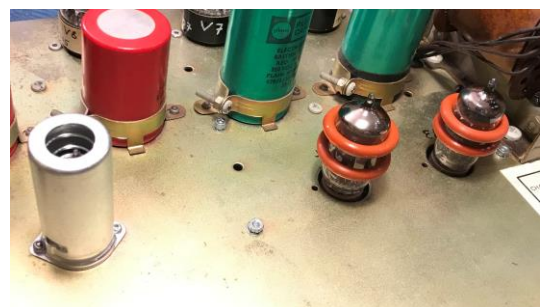
On the top side of the chassis the shielding of V2 is mounted with a reduced spring in the head thus leading to reduced direct coupling of the tube to chassis. All other tubes of the preamp will get the typical silicone O ring dampers.

With all those mechanical measures the sensibility for microphony of the chassis could be reduced by an estimated factor of two.

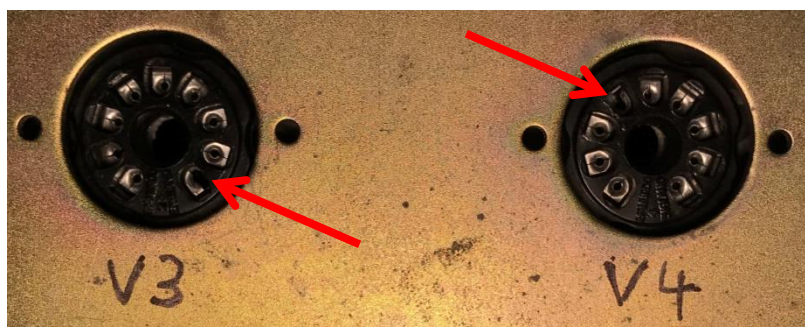
Almost at the very end of the refurbishing it has been discovered that two of the three noval tube sockets in the preamp are each damaged at one pin (see picture right side).

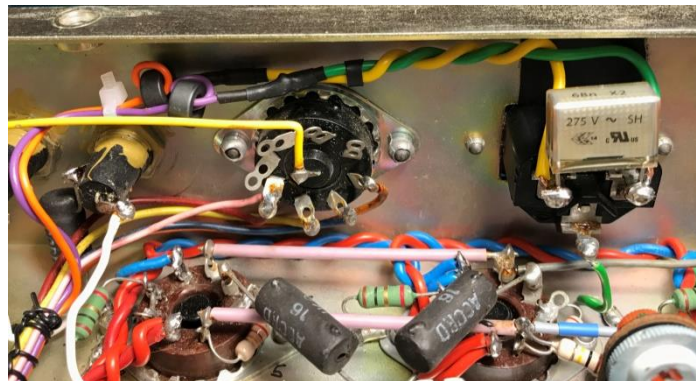
Final design with X2 capacitor and 2 ferrite rings

As discussed in chap. 1.16 the mains supply input will be protected with an X2 capacitor $68nF$ $275VAC$ (PME271M568MR30) and two ferrite rings.

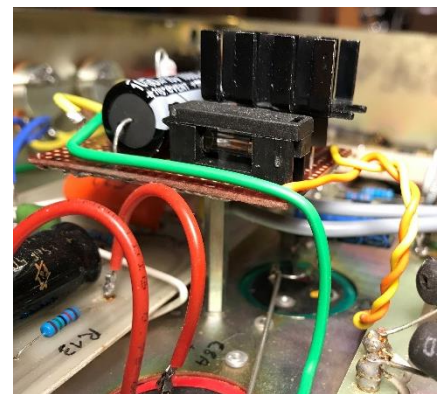
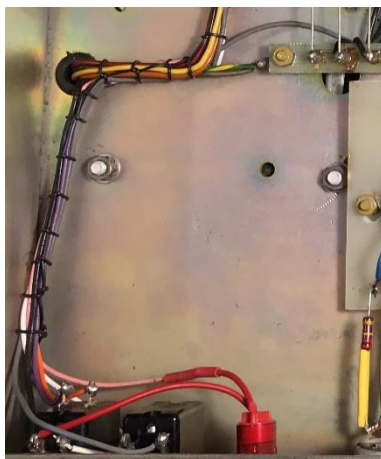
Before

To provide a better cooling to the full bridge rectifier a heat sink is mounted on housing of the NTE53000. The part itself is mounted with distance to the PCB (~5mm).

To manage the electrical heater balancing a humdinger pot is integrated ([1] Blencowe, chap.3.16). This tap can only be effective if the original center tap of the heater supply directly at the transformer is disconnected.

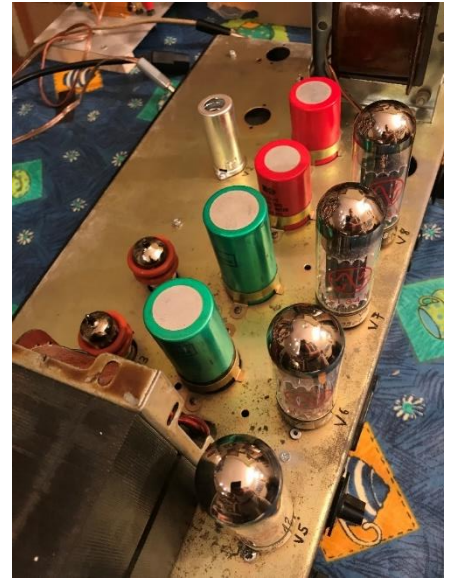
The chart below shows the comparison of the characteristic curves between the “old” V2 Siemens ECC83 and the replacement JJ ECC83S. Both are inside the tolerance limits for new ECC83 tubes (green dotted lines).

All ECC83 show no abnormalities during the characterization on the tube tester. During the hum noise investigation in chap. 3.11 also no clear dependence of the old ECC83 via temporary exchanges could be identified. Finally, V2 is substituted by a new JJ-ECC83S, which has a tension grid and because of that should be less sensitive for microphony.

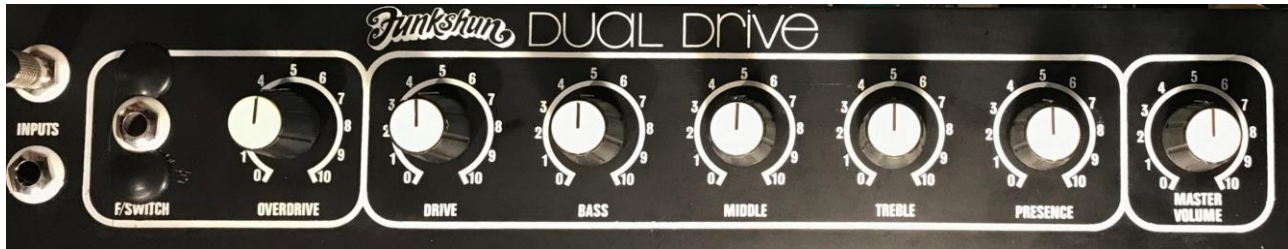
FA.20.a) (190_001)

Complete signal path LOW gain input

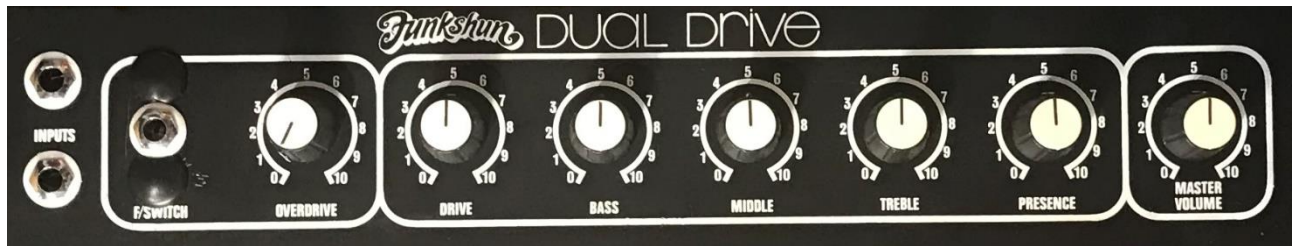
FB.20) (187_000) Complete path

Ch1= V2a ECC83 / Pin 2

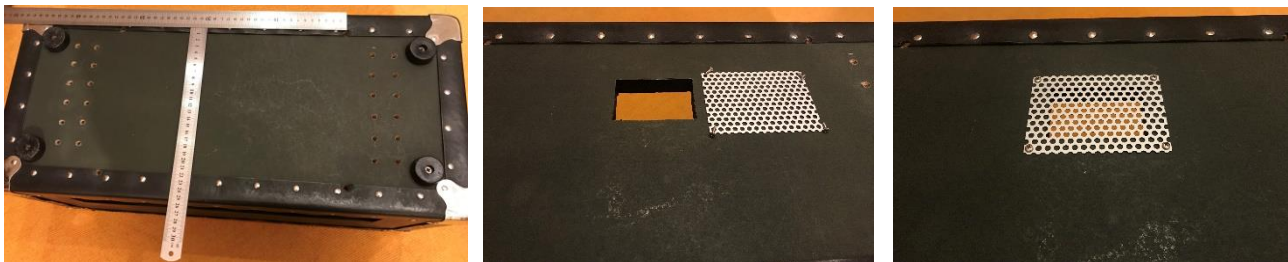
On the bottom of the case a further opening for cooling has been added.

The opening was exactly placed above respectively below the cooling sink of the rectifier for the DC heater supply. Inside the case a self-adhesive aluminium foil was mounted to provide a better shielding for the chassis which is open at that side. In most of the Fender amps such shielding foil is assembled.
